Preventing Common Electrical Problems

Jim Donald, Extension Engineer; Jess Campbell and Dennis Brothers, Poultry Housing Specialists; and Gene Simpson, Extension Economist; National Poultry Technology Center, Auburn University

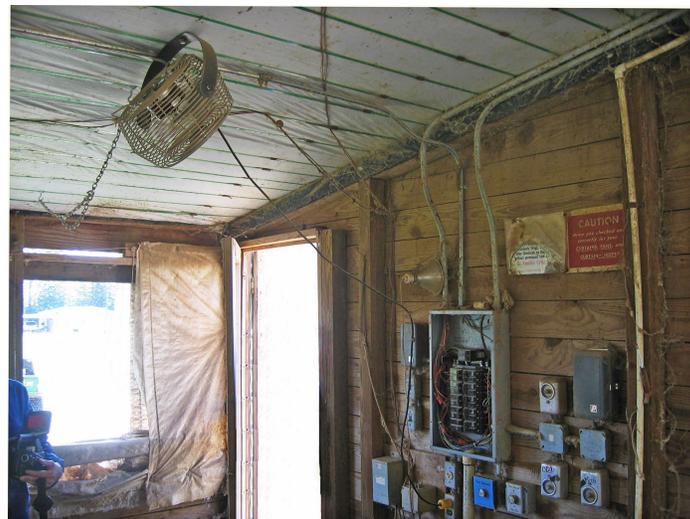
Photo 1: Electrical panels with covers removed and fans blowing on the breakers to keep them cool – sure signs of an inadequate electrical system that is likely to fail abruptly.

Learning about the importance of a properly sized, installed and maintained electrical system will help prevent system failures. A tripping breaker or hot power panel, see Photo 1, indicates something is wrong and must be repaired. In an environmentally controlled house, regular electrical maintenance has to be part of the production program.

Many growers remove panel covers or even blow fans on breakers to keep them cool, as shown in Photo 1 on page 1. A properly sized circuit breaker snapped into a quality panel with copper bus bars and the correct wire properly connected to the load won’t need to be cooled by a fan or have the cover removed. This is a tell tale sign that you need to have a knowledgeable electrician take a look at your farm.

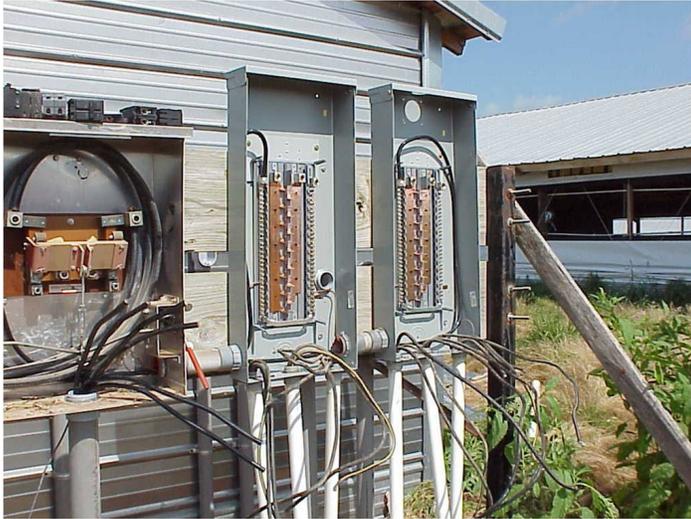
Photo 2: *What's wrong with this picture? New electrical service and panels are being installed to handle the increased electrical load of an upgraded environmental control system – but the old wires leading from the panels are not being replaced. They are now undersized and likely to fail.*

Also, special attention should be taken when retrofitting older houses with new tunnel fans and equipment. Sometimes the older 100 amp rated feeder wires are used to feed 200 amp panels that supply the more powerful equipment, see Photo 2. The old conductors are not rated to handle the new load but will work or get by for a while. The correct

action is to replace the wires serving the panel. This is an expensive fix and is often not done. Have a qualified electrician size and install new feeder wires and use copper if at all possible.

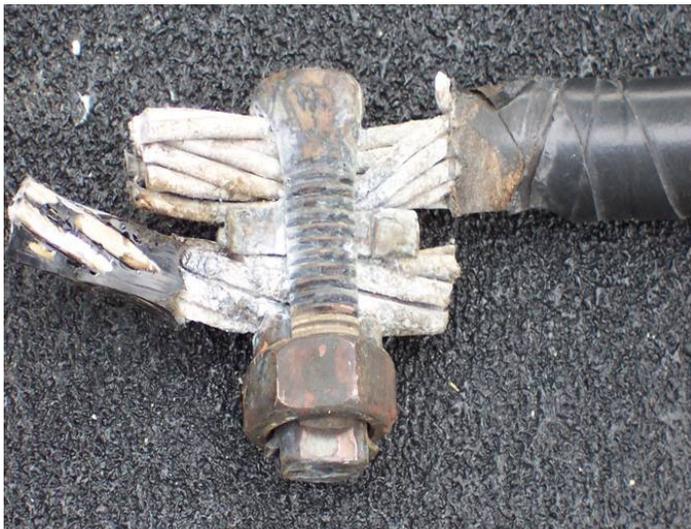
Photo 3: *Wires incorrectly connected with a split bolt connector.*

Over time the resistance of this connection increased, the junction began to heat up, and the two conductors burned apart. This could have been aggravated by moisture causing corrosion of the aluminum, or by unequal expansion and contraction of the metals.

Whatever the specific cause, the split bolt connector splice failed. Since the failure was down stream of the generator, power to the turkey house being served by that set of conductors was lost. As stated previously, there is no fast fix for a failed feeder to a turkey house.

Photos 3 and 4 show the right and wrong way to connect two or more wires together. The wires in Photo 3 are connected using a split bolt connector.

Split bolt connectors have been commonly used in retro-fitting electrical systems to join old buried conductors to new panels. They are often protected by electrical tape and might even be buried or hidden in a piece of electrical conduit. This makes them difficult to inspect. Most likely sooner or later these connections will cause trouble. If you have them in your wiring system, you need to plan to replace them.

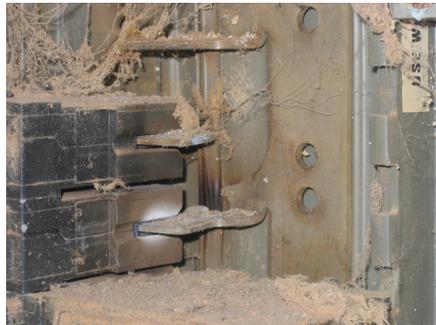
Photo 5: 15 year old panel with a 170°F (77°C) hot spot.

The connection of the breaker to the aluminum bus of the panel has deteriorated and is the cause of the problem. Eventually, the hot spot will melt or burn through, causing loss of power (or worse, a catastrophic fire).

Photo 5 shows a panel in a 15 year old house that has a hot spot heated up to nearly 170°F (77°C). The problem is not easily noticeable to the eye, but shows up clearly in an infrared photo, see Photo 6.

The panel board should be replaced with a commercial grade model properly sized for the connected loads.

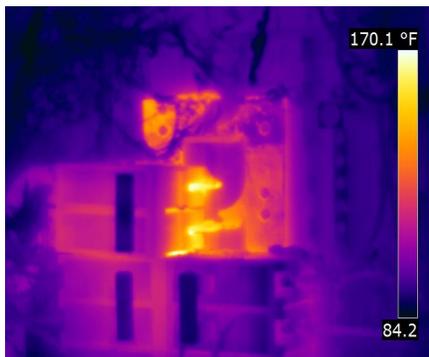
Photo 6: Infrared photo of 15 year old panel with a 170°F (77°C) hot spot.

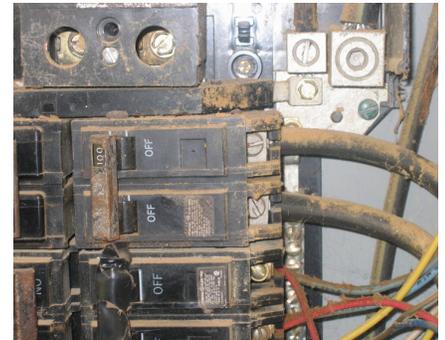
Photo 7: Overheating circuit breaker.

A breaker that always needs to be changed is a sign that something much worse is wrong. Photo 7 shows an overheating circuit breaker, operating at about 130°F (55°C). It was caused by using a poultry house panel to feed electricity to a second poultry house.
