Tighten Houses to Control Propane Use

By Garrett L. Van Wicklen, Applied Poultry Engineering in Seaford, Delaware

A technical publication from Aviagen Turkeys - USA

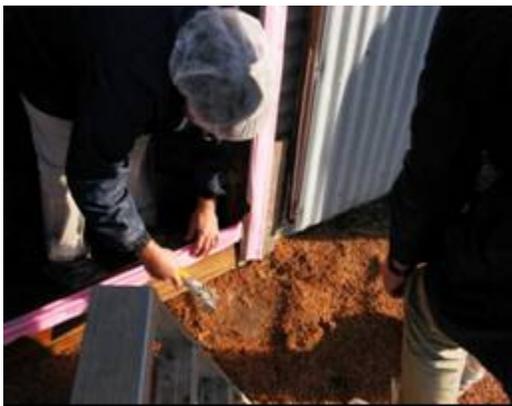
Photo 1: Install polystyrene tape weather-stripping around the perimeter of end doors to improve their seal.

Sealing end doors tight begins by cleaning litter away that might prevent doors from sealing against adjacent end walls. To help seal these doors tighter, polystyrene tape was applied around the perimeter of the door, **see photo 1**.

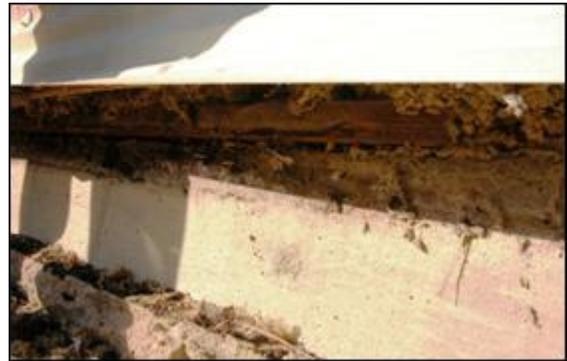
Photo 2: The gap between the top of the foundation and lower plate is a source of cold air leakage on birds and litter.

Older houses (and even some newer houses) leak air between the top of the foundation and the lower sill plate, **see photo 2**. To check for leakage, turn on some fans and generate smoke outside near the foundation while another person watches for smoke inside the house, **see photo 3**. Cold air entering at this point will blow directly onto young birds and cause wet litter resulting ammonia generation.

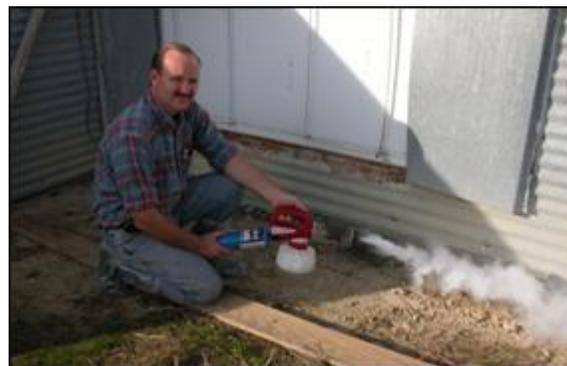
Photo 3: Generate smoke outside the house near the top of the foundation to see how much leaks into the house.

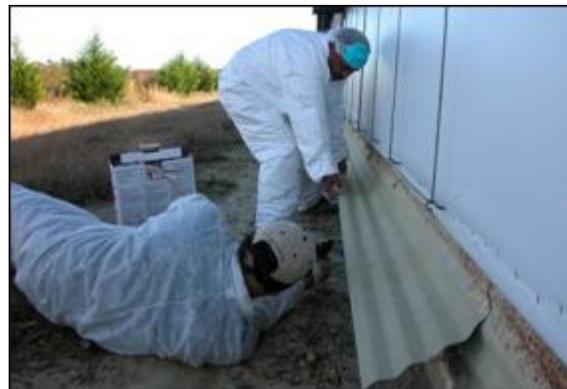
Photo 4: Spray foam being applied to fill the gap between the plate and top of the foundation.

At our example house, the gap between the foundation and plate was filled with spray foam from outside the house in combination with the polystyrene rope style weather-stripping material, **see photos 4 and 5**. Using any type of foam material to seal gaps might only be a temporary fix without adequate darkling beetle control. Beetles love to eat foam insulation. Caulk or tar may prove to be a more durable product in this case.

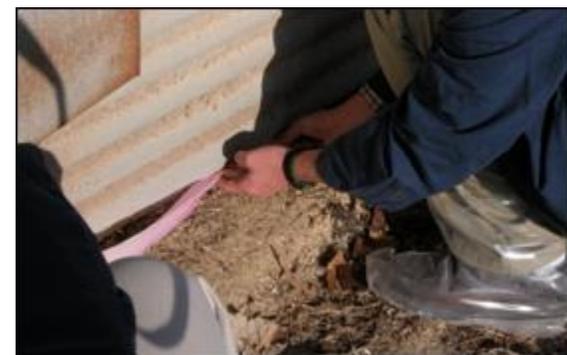
Photo 5: Polystyrene rope and tape can be used to seal air from entering between the wall metal and the foundation.

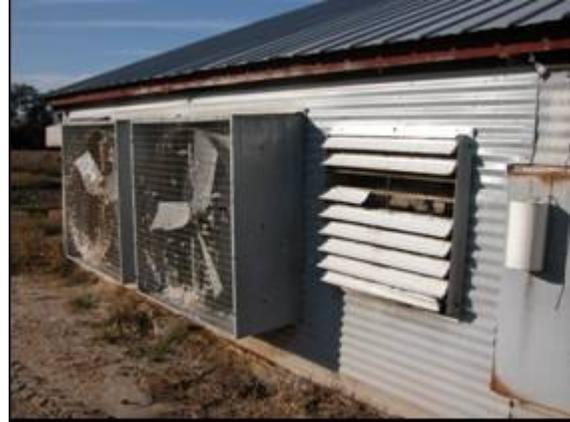
Photo 6: Replace broken fan shutter panels. Don't leave a permanent hole for cold air to enter the house

Fan shutters need to be cleaned each flock so that they move freely and fully close when the fan isn't operating. If you have panels on fan shutters that are broken, replace them, **see photo 6**. That hole in the fan opening will cost you much more in gas than the shutter panel.
