BASIC FAN MAINTENANCE IMPROVE PERFORMANCE AND LOWER ELECTRICAL COST

GARRETT L. VAN WICKLEN – EXTENSION POULTRY ENGINEER – UNIVERSITY OF DELAWARE

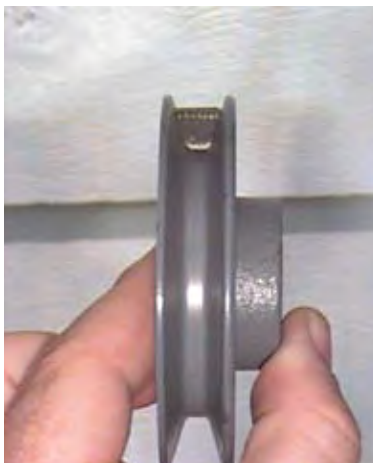
Figure 1.
A worn fan belt riding low in the pulley reduces the effective pulley size. This belt should be replaced.

Many growers are very surprised to learn that fan belts don't stretch. Fan belts wear from their sides and drop lower into the pulleys. As with cleaning fan shutters, many growers don't care that a fan belt is riding low in the pulleys. They will replace the belt as close to its breaking (sometimes after the fact) as possible. This might not be a wise strategy.

The top of the belt should ride slightly above the top of the fan pulley. A worn fan belt will drop down into the pulley so that the top of the belt cannot be seen in the pulley.

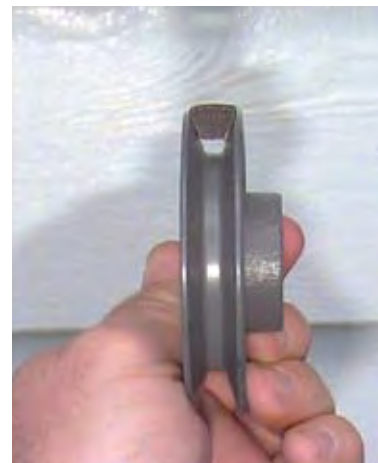
Figure 2.
A new fan belt rides high in the pulley so that the top of the belt rides just above the top of the pulley.

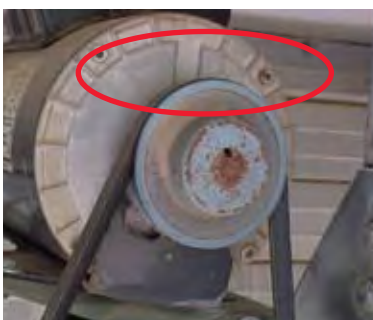
Figure 3.
Front view of a new belt riding slightly above the pulley

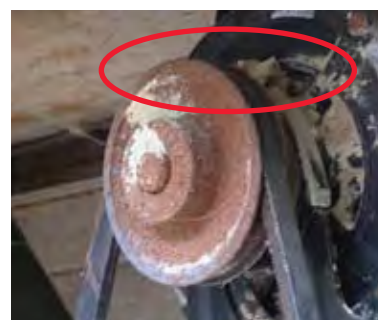
Figure 4.
A front view of a worn belt riding low in the pulley

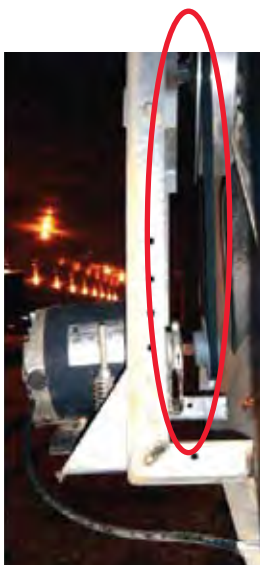
Figure 7.
This fan motor and pulley are being pulled upward because of poor support on the fan frame.
